Fundamental issues in Japan's coastal management system for the prevention of beach erosion

Takaaki Uda*

Public Works Research Center and Visiting Professor of Nihon University, Taito, Tokyo 110-0016, Japan

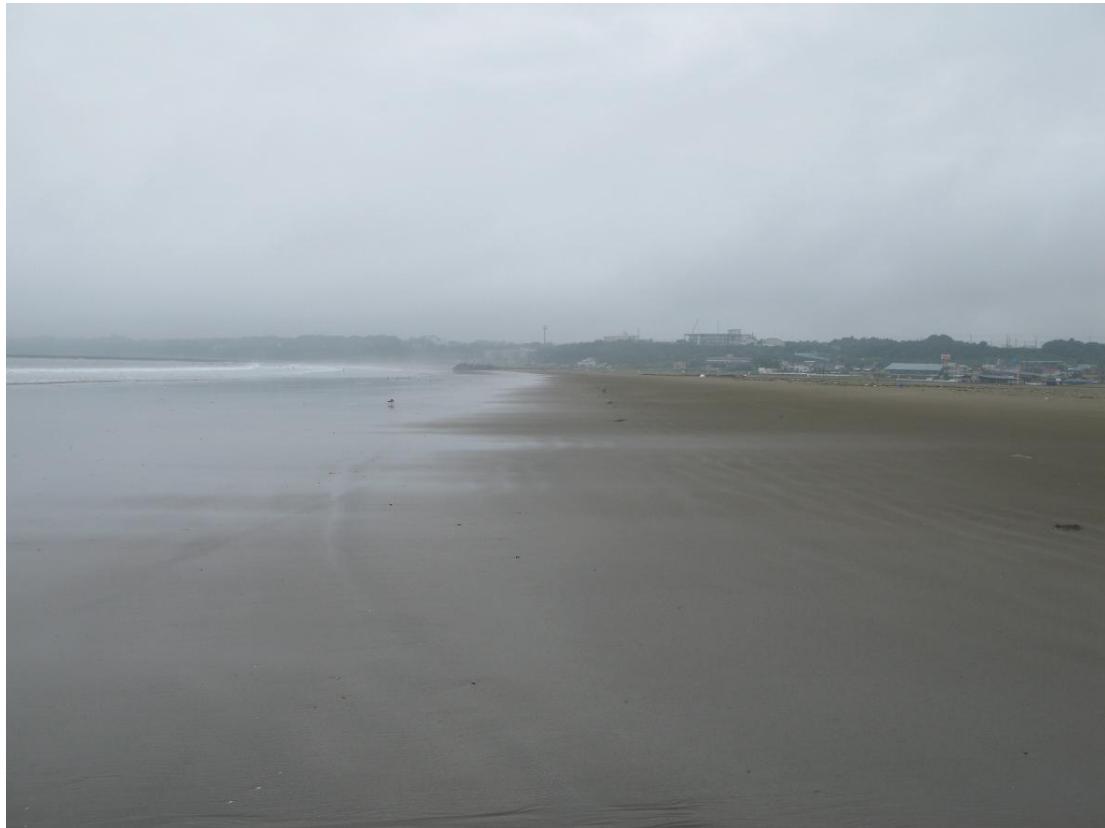
Figure 3 Foreshore at south end of sandy beach in wave-shelter zone.

The changes in coastal conditions inside and outside the wave-shelter zone can be well documented from the differences in coastal conditions at 3 points, as shown in **Figure 2**. First, **Figure 3** shows a photograph of the beach at St. 1 at the northern end of Oharai-san Beach, taken on July 6, 2015, facing southwest. A large amount of fine sand of median diameter of 0.19 mm (Uda et al., 2020) had been deposited in the wave-shelter zone, forming a very gentle foreshore slope. The coastal conditions at St. 2 south of artificial headland No. 40 are shown in **Figure 4**. The sandy beach ended here, and the coast covered with the seawall and concrete blocks began. Further south, the coastline was heavily protected by a number of rocks and concrete blocks at St. 3 (**Figure 5**) for a long stretch of coastline, which contrasted well with the north coast at St. 1, and it was difficult for beach users or fishermen to approach the shoreline, owing to the blockage by concrete blocks. Despite the protection, a cave-in was found immediately behind the seawall because of the discharge of fill material underneath the seawall, and subsidence of the blocks had occurred.

The very gentle slope inside the wave-shelter zone was in strong contrast with the eroded coast, as shown in **Figures 3 and 5**. A beach was formed by the deposition of a large amount of fine sand in the wave-shelter zone, whereas an eroded and devastated coastline was left over a distance of 5 km south of the port.

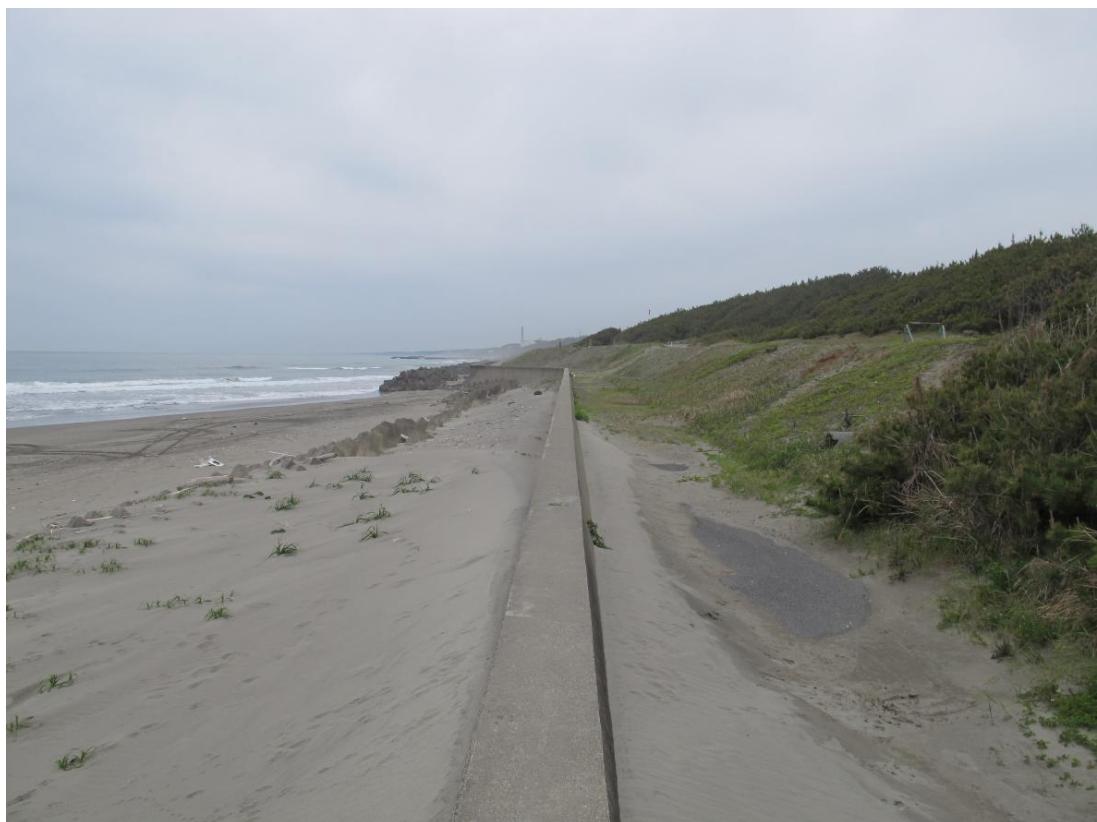
Figure 4 Sand deposition at boundary between accreted and eroded beaches.

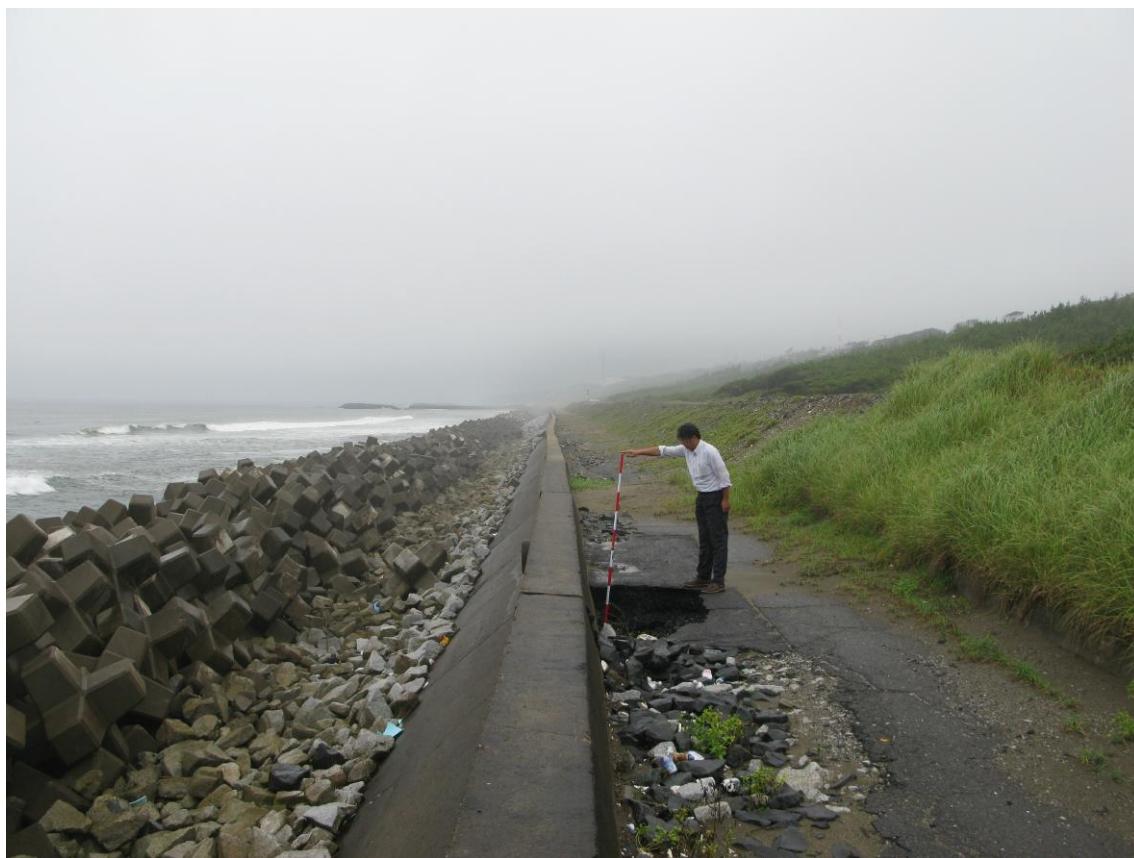
Figure 5 Artificial coastline protected by seawall and a number of concrete blocks.

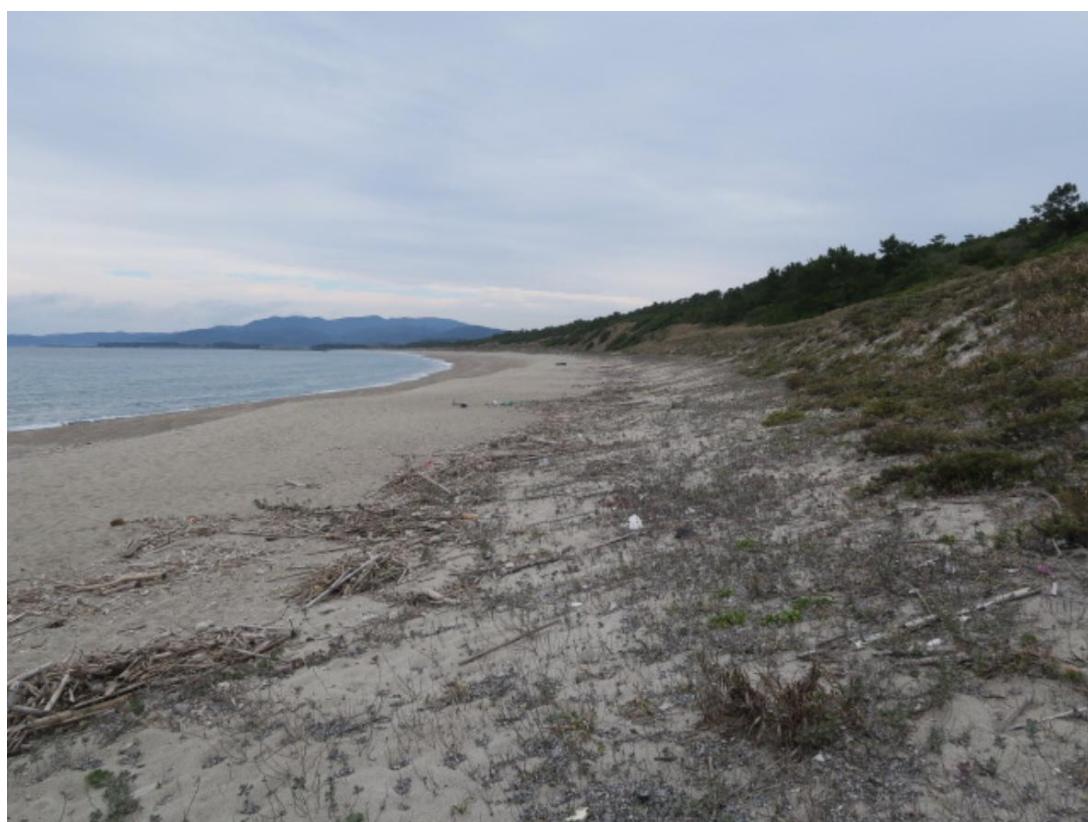
Figure 11 Photograph of sand dune and backshore taken at St. 1.

On December 7, 2019, field observation was carried out; the coasts at the south end of the pocket beach and near the south end of the detached breakwaters south of Ichiki Fishing Port. In the satellite image of this area (**Figure 10**), the numbers of sites where photographs were taken are shown. **Figure 11** shows the photograph of St. 1 in the backshore area at the south end of the pocket beach, facing the north. A gentle slope extended from the sand dune to the shoreline, with a backshore covered with low coastal vegetation. In front of the vegetation, a wide, natural sandy beach of 50 m width extended (**Figure 12**).

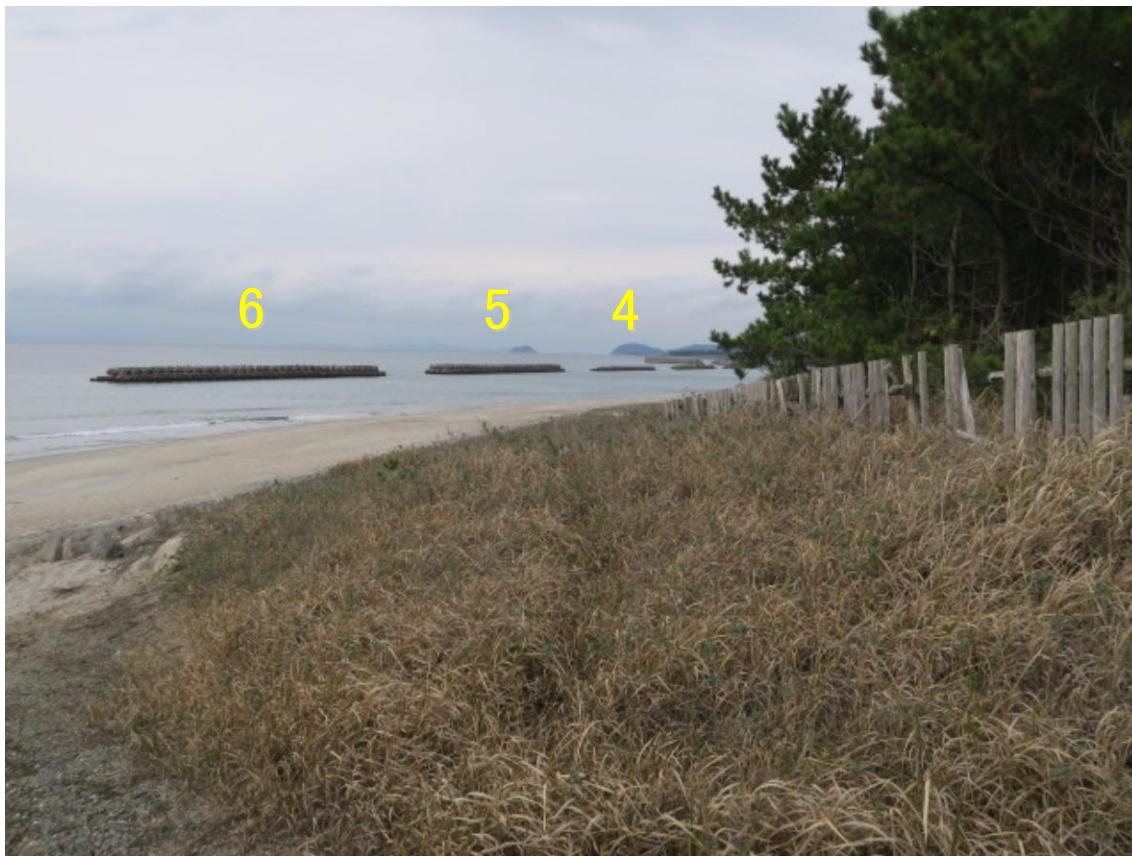
Figure 13 Photograph of coastal conditions at south end of detached breakwaters taken at St. 3.

Figure 13 shows the coastal conditions at St. 3, close to the Osato River mouth. In the offshore area, detached breakwater Nos. 4, 5, and 6 can be seen, with the formation of a sandy beach behind each detached breakwater. The beach conditions south of St. 4 is shown in **Figure 14**. Although the seaward slope of the sand dune was densely covered with coastal vegetation, it was found that coastal forest disappeared at the location encircled in **Figure 14**, and a protection facility is seen in the distance in front of the coastal forest. **Figure 15** shows the shoreline at St. 5, facing the south. Around the protective structures, the slope covered with vegetation in front of the coastal forest disappeared, and the earth surface was bare owing to erosion. Furthermore, the shoreline markedly retreated in front of the area, resulting in a reduction in the beach width.

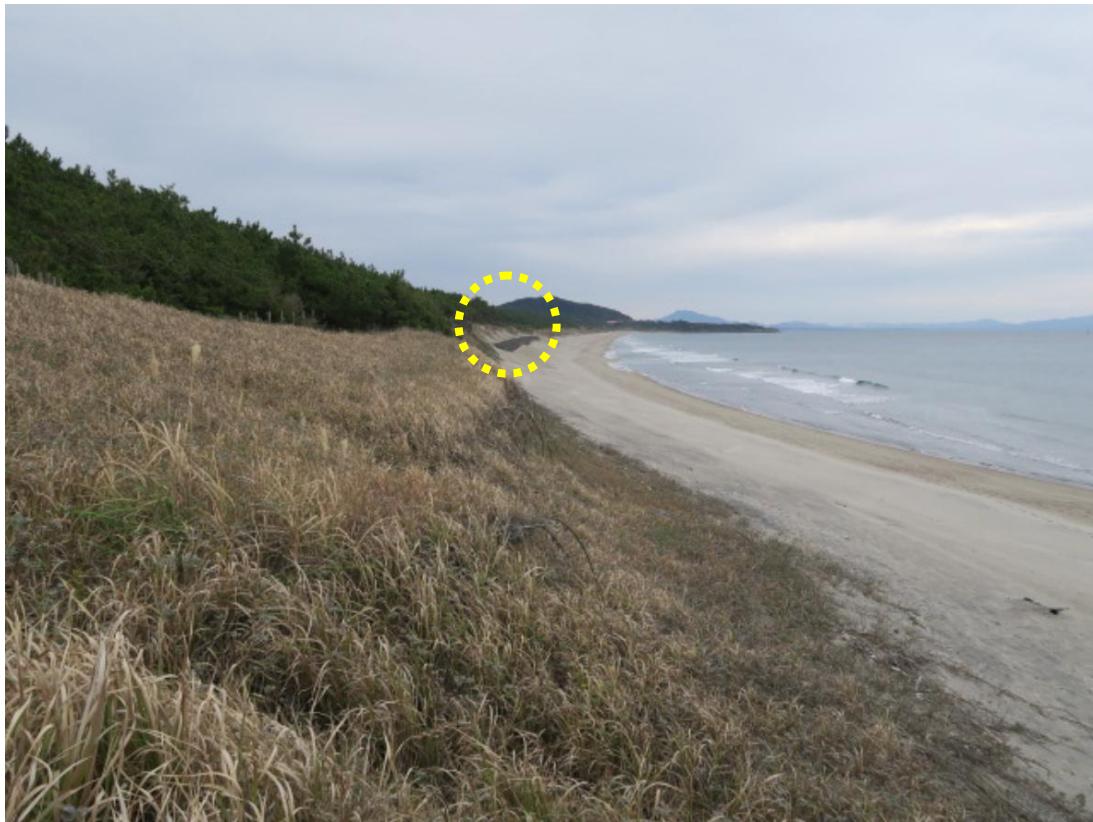
Figure 14 Protective structures, such as filter units, were seen at the location shown by a circle in front of the coastal forest.

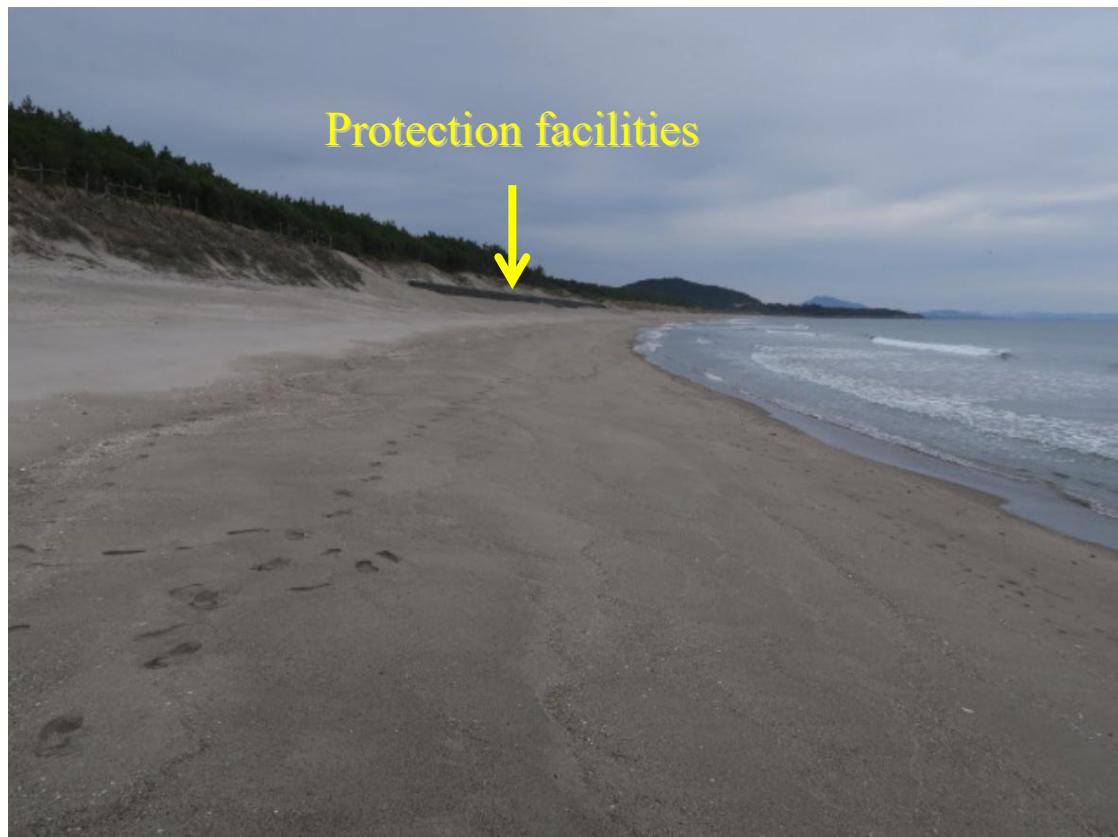
Figure 15 View of protection facilities and shoreline from St. 5.

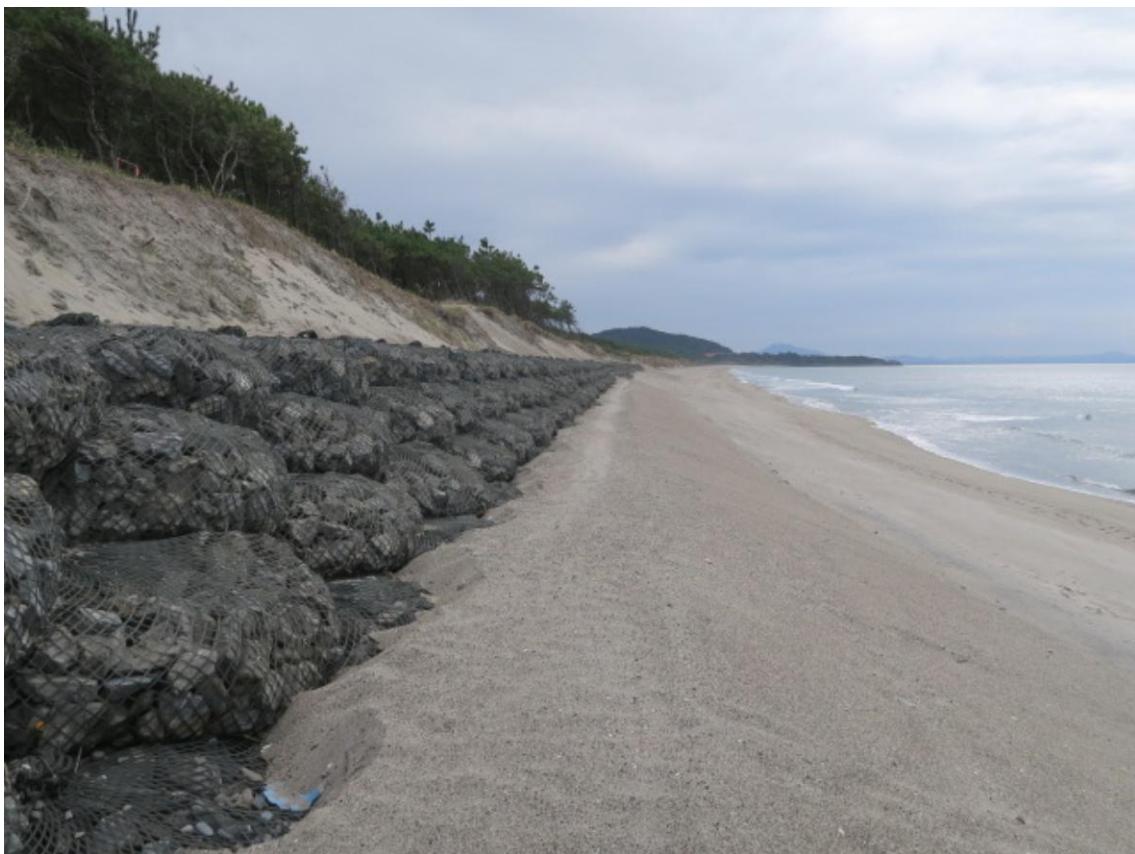
Figure 16 Close-up view of filter units taken at St. 6.

These findings imply that the beach was eroded in this vicinity, forming a scarp, and shore protective facilities were installed to prevent further erosion. **Figure 16** shows a close-up view of the facilities; many filter units with gravel inside were placed along the coastline, and extremely unnatural conditions were produced, in strong contrast to the natural conditions shown in **Figure 11**, taken at the south end of the coastline. Because this coast is a pocket beach, a natural beach can be maintained as it is, unless artificial alteration is made. In this case, as a result of the construction of detached breakwaters immediately north of the study area, longshore sand transport toward the lee of the detached breakwaters was triggered, which was the fundamental reason for the beach erosion.

In the present case, the agency administering the coastal forest, where severe beach erosion occurred, was forced to protect the forest land on the basis of the Forest Law, and filter units were placed to prevent beach erosion in the eroded area, as shown in **Figure 16**. **Figure 17** shows an enlarged aerial photograph of the rectangular area shown in **Figure 10**. Sand was transported to the lee of the detached breakwaters across the boundary between the natural coast and the area protected by detached breakwaters, forming a salient, whereas the shoreline retreated and the beach width decreased south of the detached breakwaters. Although a large salient developed behind detached breakwater Nos. 7 and 6, the size of the salient significantly decreased northward.

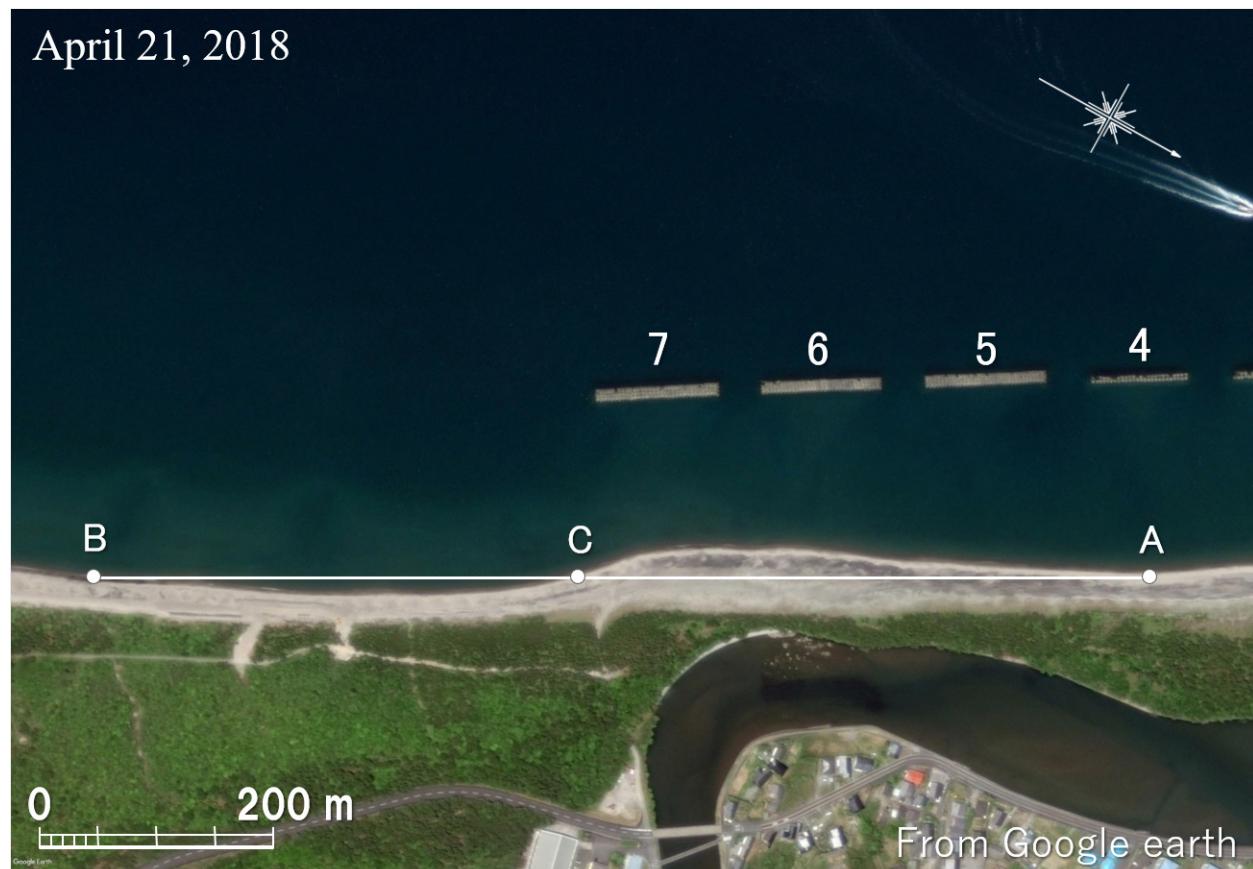
Figure 17 Enlarged satellite image of south end of detached breakwaters.

Point A was set at a location where the original shoreline was maintained because there was no marked sand deposition behind detached breakwater No. 4, and point B was set 430 m south of detached breakwater No. 7, where the effect of the installation of the detached breakwaters was assumed to be minimal. Therefore, it is considered that sand was deposited where the shoreline advanced from this solid line, and vice versa.

In **Figure 17**, the shoreline retreated between points B and C south of the detached breakwaters, and the shoreline advanced between points C and A behind the detached breakwaters at this stage. This is a natural phenomenon after the construction of a wave-sheltering structure, and beach changes triggered by the construction of coastal structures can be predicted by using a numerical model, such as the BG model (Uda et al., 2018). Even though prediction is possible, the reason why the issue cannot be solved is the separation of the agencies managing the coastal areas. The preventive measures against sand movement across the different management areas is difficult to implement because of this separation. In fact, measures have always been taken after the erosion has occurred.
