# **Initial and Planning Stages in Preservation Process, Contributions to Recommendation for Appropriate Conservation Treatments: A Case of Conservation of the Our Lady of the Rosary Church Project**

**Wimonrart Issarathumnoon**

## **Abstract**

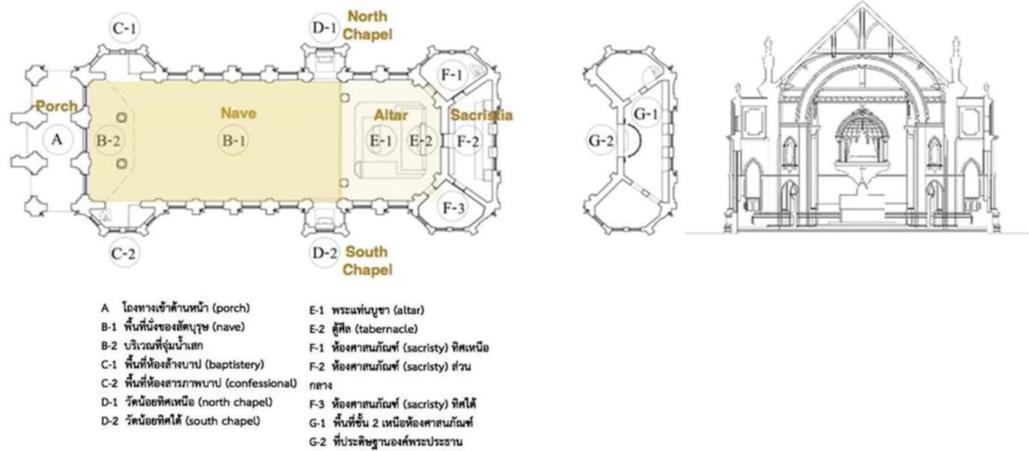
Figure 1: Plan and section of the Our Lady of the Rosary Church

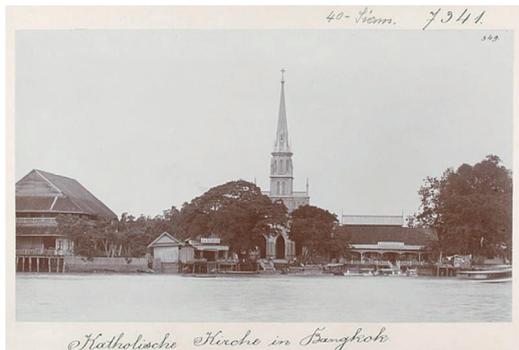
Figure 2: The Our Lady of the Rosary Church (the 3rd church) constructed in the Reign of King Rama V

Besides identifying the Church's Gothic Revival characteristics, this project also found several historical evidences indicating that Joachim Grassi, a famous western architect working in Siam in the reign of the King Rama V, was an architect who designed the existing Church building.

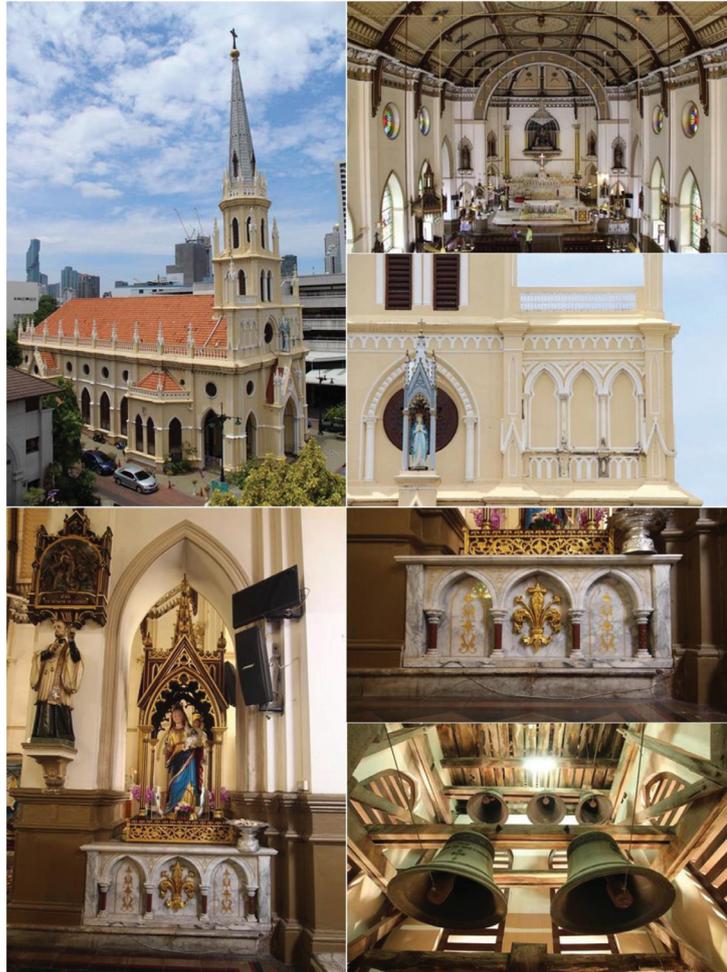
Figure 4: The Church in the Gothic Revival Style

The study involves identifying the Church's architectural characteristics that are of the Gothic Revival Style, considering space, form, and character defining features, for instance, a bell tower, a high pitched roof, rose windows, pilasters, pinnacles, lancets, and pointed arches.

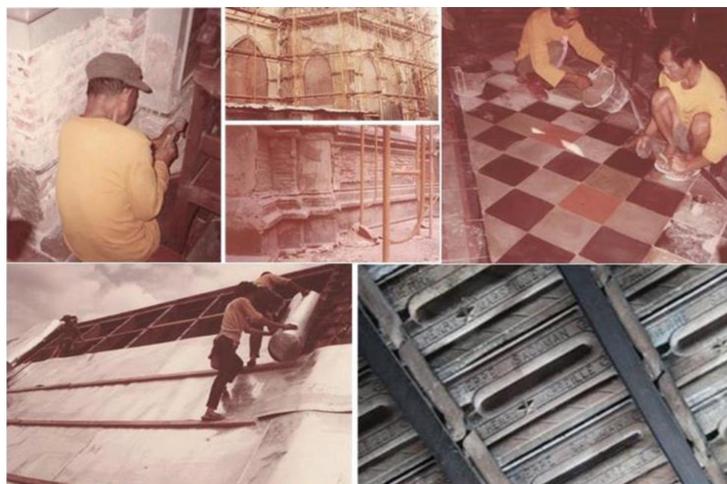
Figure 5: The first heavy restoration during 1983-1985

During the period of the first restoration work, the deteriorated components, such as the roof, tower, wall, floor, and architectural ornaments, were restored; while some poorly damaged elements were replaced with replicas. The building systems—including electrical and water drainage systems, were restored. Thanks to the proper concept of the first restoration, most of the worsened elements were repaired and replaced with quality materials compatible with the original ones. For instance, terra cotta roof tiles and cement floor tiles were well preserved. However, the replacement of Portland cement to original lime mortar has caused severe dampness problem.

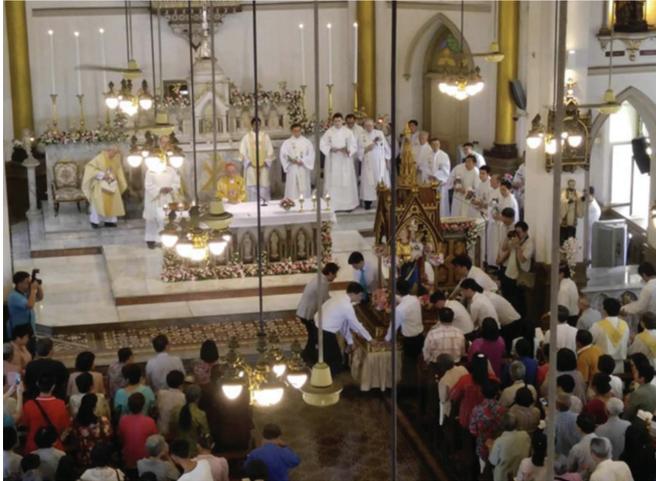
Figure 6: “A Living heritage,”  
the Church still has been  
actively used for religious  
and communal services

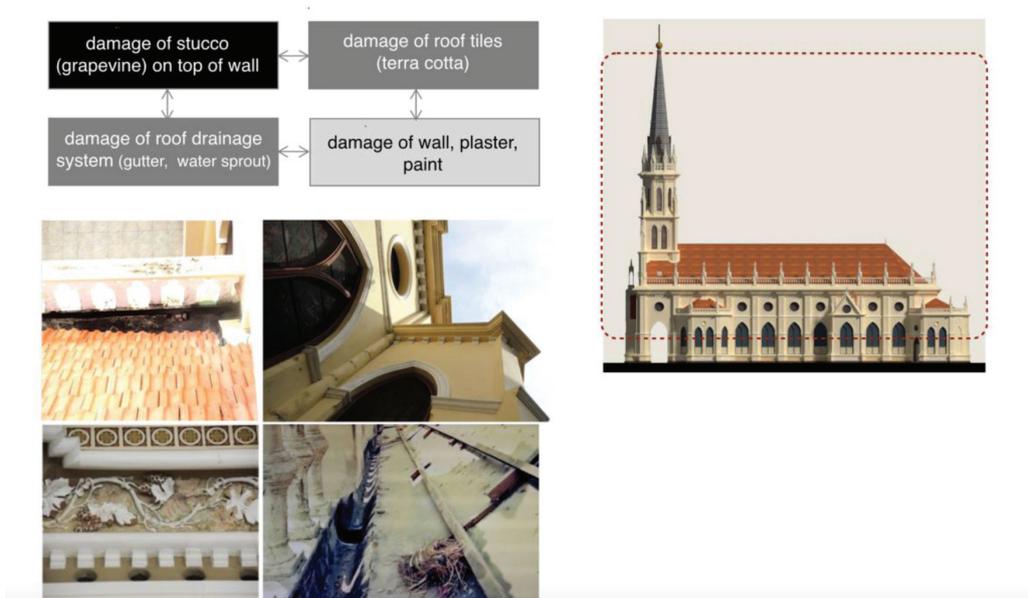
**A. Roof drainage \* Roof tiles \* External wall \*  
Internal decoration (stucco, wall painting)**

*- Group A The damages of the roof drainage features, roof tiles, interior and external walls, and wall decorations (such as stucco molding, and wall painting).*

Based on the surveys, these damages have been affected by leaking rain water from the roofs to the upper parts of walls. The damages were also caused by deterioration of the building's roof tiles, roof gutters, water sprouts, and wall bricks and mortar. The other severe problem is the deteriorated stucco molding on top of the interior walls. To stop the decay and consequential damages, the water leakage problem should be primarily solved.

Figure 6: Group A: The damages of the roof drainage, roof tiles, interior and external walls, and wall decorations

Preservation works for the first phase include: the restoration of the tower and the roofs. The roof works consist of: the repair and replacement of roof tiles, roof gutters and downspouts; and the restoration of the decorative elements of the main roof.

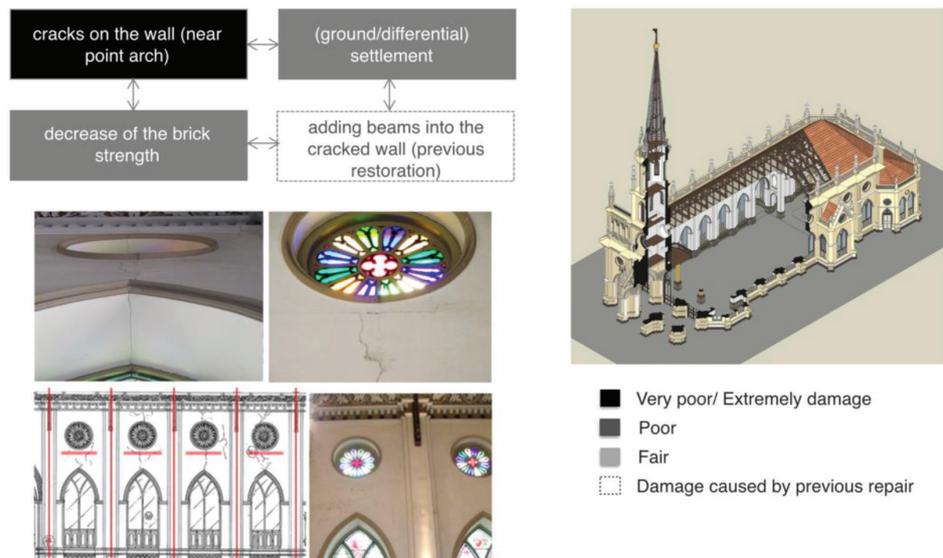
**B. (ground/differential) Settlement \* Decrease of the brick strength\*  
Cracking (cracks on the wall near point arch)**

*- Group B The problems of ground/differential settlement and decrease of brick strength causing cracks on the wall, the area between the point-arched window and the rose window.*

Analytically, the causes of the cracked wall between the point-arched window and the rose window include:

- Deterioration of bricks leading to the decrease of brick strength;
- Ground/differential settlement; and
- Consolidation technique in the previous restoration work done by adding reinforced concrete beams into brick bearing wall.

Figure 7: Group B: The problems of ground/differential settlement and decrease of brick strength, have caused extensive cracks on the wall area between point-arched windows and rose windows

The crack problem was one of the severe crises that should be urgently repaired. All causes leading to this problem should be solved. There are future works including to inspect the condition and strength of bricks, and to specify expansion of the cracks that should be done in order to gain more specific information before choosing conservation techniques. Additionally, the site's ground and differential settlement should be measured and analyzed.

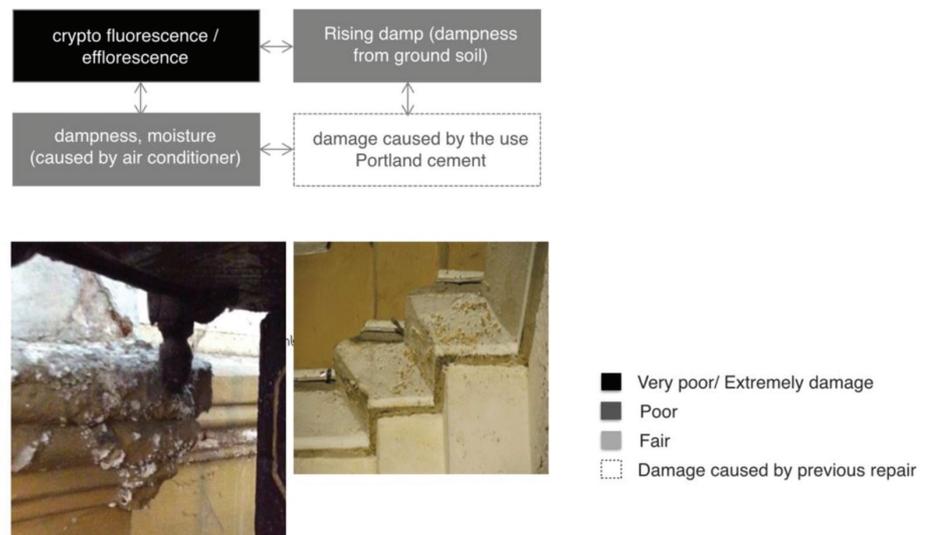
**C. dampness from ground soil \* damage caused by the use Portland cement (previous restoration) \*  
dampness and crypto fluorescence / efflorescence**

- *Group C* The problems of dampness from ground soil and damages due to crypto-fluorescence and efflorescence caused by the use of Portland cement in the previous restoration works.

Based on the building inspection, the decay of the brick walls was affected from series of causes including:

- The use of Portland cement in the previous restoration works (particularly in the mid of 1980s) has brought about the unsolved problem of crypto-fluorescence on the brick masonry wall surface. As a result, some of the bricks on the church wall have been disintegration, crumbling, blistering, and exfoliation. Some parts of the brick walls have had efflorescence formation. Some dry marks of the salts have appeared on the deteriorated wall surfaces, especially in the areas that have falling-off pieces of bricks and mortar and holes of unused electrical outlets.

- Dampness from ground soil and rising groundwater has been caused by the construction of hard surface pavements around the Church building. As a result, dampness from the ground soil and groundwater could not evaporate through the ground surface, so the moisture has passed through the porous brick wall and evaporated through the wall surface. Simultaneously, it has caused such efflorescence effect when groundwater reacted with dissolved salts. Salts deposits have created the white stains—which is dry marks of salt on the highest level of dampness –on the interior wall surfaces.

- Dampness caused by air conditioning units located in the additional confessional booth in the existing confessional area inside the Church. The surveys found that there were some water and salt stains on the surface of the walls in this area.

Figure 8: Group C: The problems of dampness from ground soil, crypto-fluorescence and efflorescence, caused by the use Portland cement in the previous restoration works

The presence of crypto-fluorescence and efflorescence caused by dampness and dissolved salts should be raised as a hazardous problem. The salts should be examined through a laboratory study in order to find a proper technique to remove the salts and to prevent the agents bringing further damages to the building.

The works in this phase comprise of solving the problem of dampness in the Church building walls by replacing the existing hardscape pavements around the building with softscape features to allow water evaporating through a breathing material. The other main works is the restoration of the deteriorated walls that includes: consolidation of brick masonry wall; and replacement of Portland cement mortar with lime mortar. It is also recommended that an electrical wiring system on the wall be planned ahead in order to be completed in this phase.

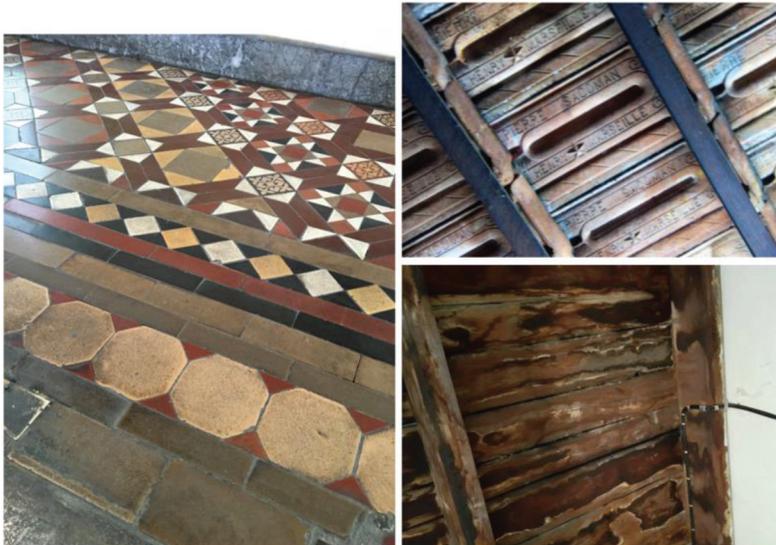
**D. deterioration of materials**

- *Group D* Deterioration of materials

The deterioration of materials was divided into several groups based on types of architectural elements, for instance, roof tiles, wooden doors and windows, and stain glasses. To

Figure 9: Group D: Deterioration of materials

preserve the original materials and characteristics, thorough inspection and condition assessment of each building component is required in order to minimize replacement of original items and materials as well as to prioritize and quantify repair and replacement work.

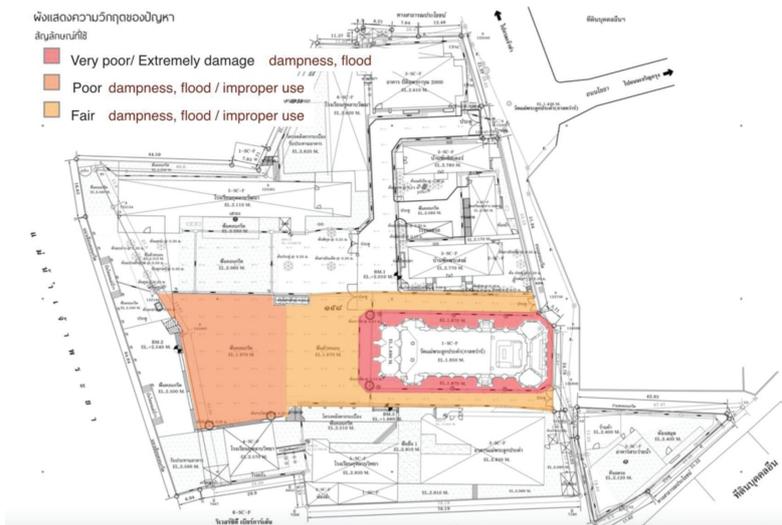
- Physical problems of the site surrounding

Based on inspections, the occurrence of flood waters during heavy rain or high tide should be raised as one of the severe problems that need to be solved as early as possible. The site's water drainage system needs improvement on urgent basis and the investigation of the cracks on the concrete embankment along the River should be conducted.

Figure 10: Physical problems of the site surrounding

Not only that does the improvement of the site drainage system need to be done, but an interpretation plan to present the history of the Church through various kinds of tools should also be conducted. Moreover, the site's landscape should be improved in term of visual quality of the site. Architectural landscaped elements surrounding the Church building should be redesigned, especially for the waterfront area.
