Collapse of Khmer stone architecture: was it caused by the lack of structural knowledge or extrinsic environmental factors?

Nuanlak Watsantachad, Ph.D.
Faculty of Architecture, Silpakorn University

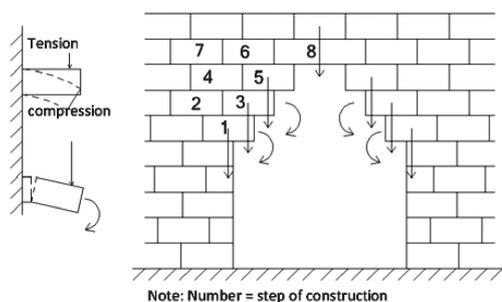
Figure 3: Cantilevered effects in corbelled roofs and openings

Corbelled roofs act vertically in compression rather than in diagonal thrusts as in true arch constructions. Each stone performs as a compressive support and transforms loads through the stones beneath. Therefore, it acts as a cantilevered beam with limitations on the length of overhang, and when cantilevered effects occur in a stone block, tension created at its upper part and compression developed at its lower part (Gordon 1991 and see Figure 3). However, stone is weak in tension and strong in compression, it is therefore not subjected to support tension or shearing stress and tends to be broken or split easily when used as a beam—either cantilever or normal. Regarding cantilever effects in corbelled arches, the deformation will occur when the strength of the stone has reached its limit due to overloaded stresses, especially tensile stresses. Because of this limitation, corbelled vaults can cover only narrow-spanned spaces—up to three to five metres (ibid).

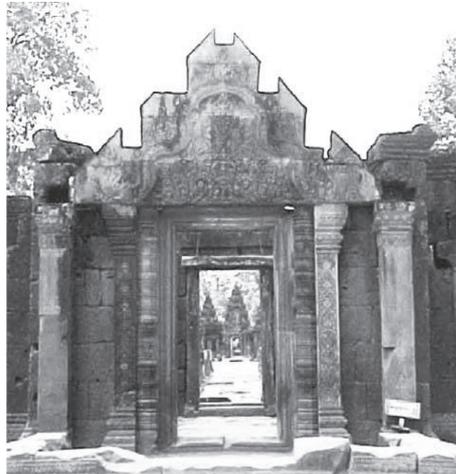
Figure 8: Evidence of wooden beams inserted in a gable (Banteay Srei, Cambodia)

Khmer roofs are generally composed of stones placed with a header-bonded dry masonry technique as corbelled vaults. Each stone roof element is placed horizontally, partially projecting over those below, and the loads are then transmitted directly to the lower stones in compression. Interestingly, a characteristic of the working of stone roof blocks is the joggle joints on stretchers (JSA 2000) imitating halved joints in timberwork (see element B in Figure 4). In terms of carpentry, a halving joint joins two pieces of wood by cutting away an end of each to half its thickness and fitting the cut ends together (Agnes 2008). The form and direction of these joggle joints on each roof element can also demonstrate the construction process of Khmer roofing as well as allowing the reassembly of fallen stones to their former positions (see Figure 5). It was the skill of the ancient Khmer people to construct the roof with this special joint both to interlock the stones safely and to prevent rain leakage. The joggle joints vastly increased the friction between the blocks and hence made the roof stable and, with the slope outwards from the joints, drained water away from the building (see element B in Figure 6). However, the drawback of cutting away a half of the stone's thickness is that it might have introduced a zone of weakness to the stone simultaneously. In some cases, wooden beams were inserted into the gables, either to support wooden rafters or to supplement a corbelled vaulted stone roof (see Figure 7 and 8).

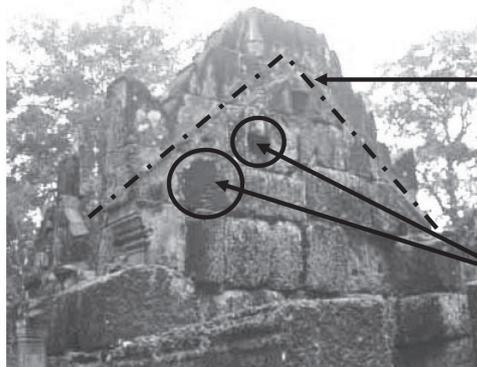
Figure 11: Carved stone blocks with a L-shaped section (Banteay Srei, Cambodia)

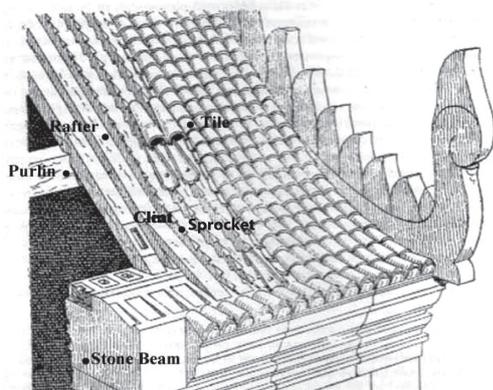
Figure 12: Wooden roof structure (Parmentier 1936)

Figure 12). As previously described, the farthest end rafters were sometimes also placed on the L-shaped section stone blocks at the gables as seen at Banteay Srei. Unlike the corbelled vaulted roof, the Khmer wooden roof was concave, and a sprocket was inserted at the base of the roof to achieve such a shape. Such a roofing system has been reconstructed from the evidence of gable ends and fallen tiles, for no such roofs survive.

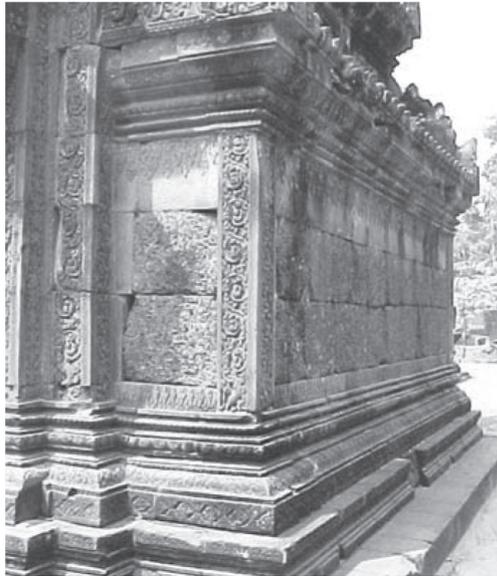
Figure 13: Wall of Banteay Srei, Cambodia

The dimension of the walls was usually predetermined by the number of masonry courses. The first two courses of masonry normally formed the base of the wall up to the sill of the window frame. Window frames were four or five courses in height with three courses above to the springing of the corbelled roof. However, the height of the wall may have varied from monument to monument. At Bateay Srei in Cambodia, the monument is not human-scaled but smaller, so that the entire wall is only three or four courses high. Interestingly, at Banteay Srei, the walls were composed of vertical stones at each corner to frame the wall; the spaces within the frames were filled with stone blocks. The wall construction, therefore, was built as if it were a post-and-beam system rather than a wall bearing system (see Figure 13).

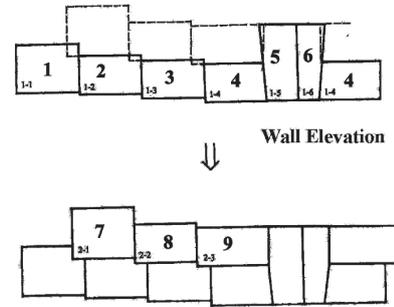
Figure 14: Order and direction of stone laying (JSA 2000)

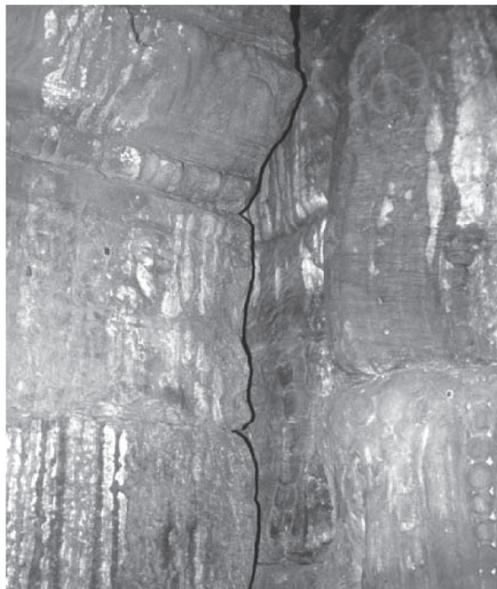
Figure 16: Construction of a wall corner with an addition wall added to the original wall with an overlapped decorative craved stone. (Banteay Chmar, Cambodia)

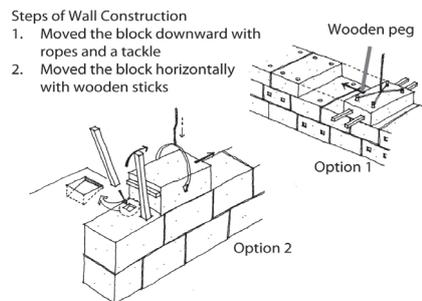
Figure 17: Process of wall construction

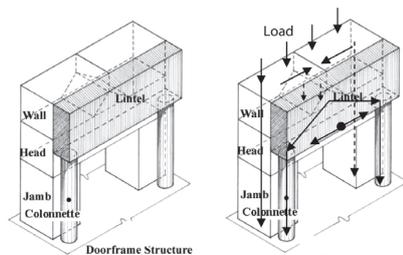
Figure 18: Schematic drawing of Khmer doorframe and thrust diagram in door set

In using these various techniques, it can be observed how Khmer architects and masons tried to solve structural problems without damaging the aesthetic design. The special techniques of frame construction described above can only be observed from the interior or after dismantling because they are hidden behind a stone lintel placed in the front. When viewed from the exterior, only the double doorframe structures—an actual doorframe and a set of lintel and colonnettes—are exposed (As seen in Figures 18).

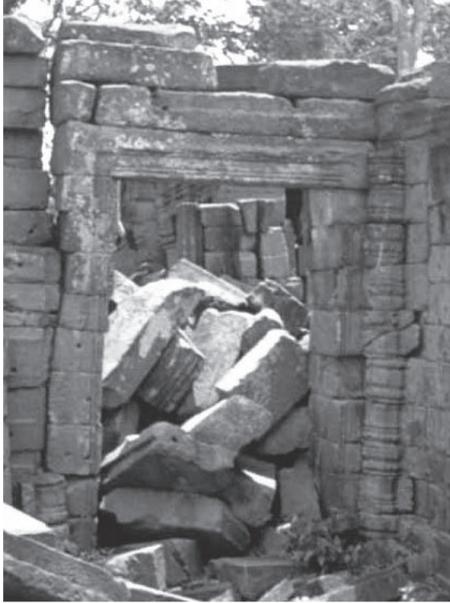
Figure 19: Door jambs composed of stone blocks (Banteay Chmar, Cambodia)

shorter horizontal element, which means that it is not as long as the actual opening. At the entrance or main doors vertical sandstone pieces with vertical bedding planes are used for the jambs of the door, whereas the jambs of some minor doors are not made of a single piece of stone (see Figure 19).

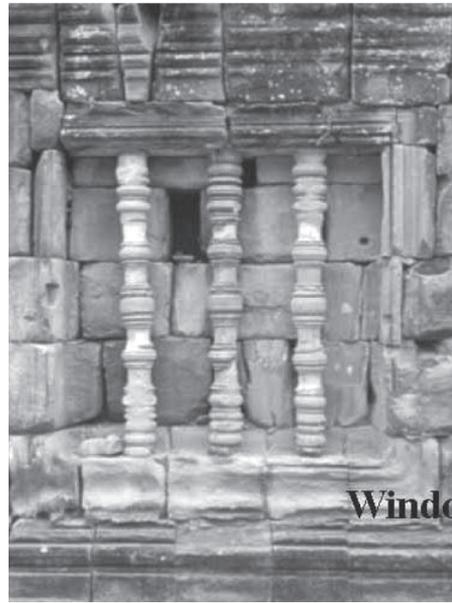
Figure 20: Window jambs with supplementing stone blocks (Banteay Chmar, Cambodia)

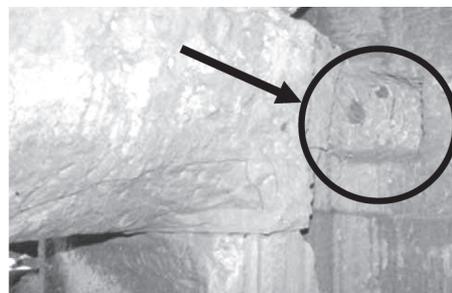
Figure 23: Square holes on the walls near a door head (Banteay Chmar, Cambodia)

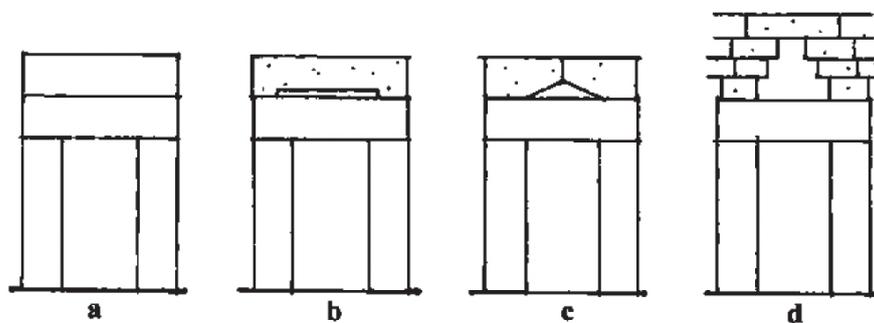
Figure 24: Different types of doorframe structure

cut only at the base to form a triangular-shaped hole (See Figure 24c). Consequently, fixed loads over the head could be dispersed to the sides with this technique. This technique can be seen in several monuments built in the Post-classical Angkor period, for instance the Northern Library of Bayon and Banteay Chmar in Cambodia. The other technique that was applied to the frame structure is the separation of two door heads—one laid on top of the other—with a gap in the middle of the upper head (Figure 24b). Again, this technique helped divide the loads from the upper part onto two sides of the lower head which decreased the risk of tensile cracking of the door head. However, this technique may lead to the weakening of the upper head due to its loss of thickness. Another technique that can be found on doorframe structures is the combination of the post-and-beam and the corbelled-arch system. Since a lintel in drystone masonry generally supports only triangle-shaped loads over it because of the corbelled structural effect (see Figure 26) and most of the upper loads are transferred to the ends of the upper head and to the jambs, leaving the middle or most of the head free of loads, the blocks in the triangle may be removed. Figure 24d shows how the stone blocks were placed in the corbelled-arch system over the head of the frame to eliminate the load in the triangle (see Figures 24d and 25d). Khmer masons sometimes used forcing wedges to reinforce vaults above lintels (see Figure 27). This solution gave a fairly successful result in decreasing loads over lintels by yielding an arch-like load effect (Gordon 1991).

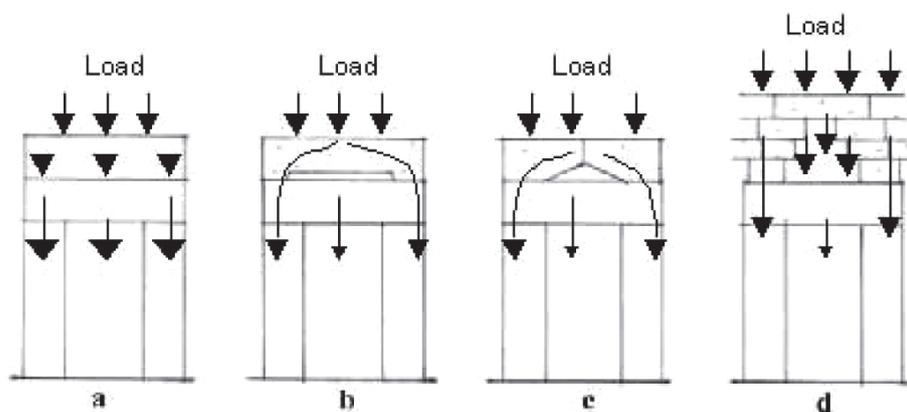
Figure 25: Loads over different doorframes

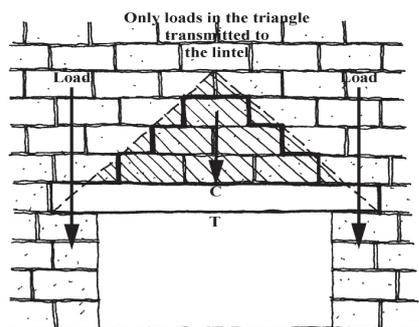
Figure 26: Loads over a lintel with a corbelled-like effect

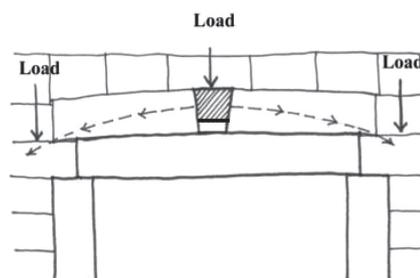
Figure 27: Wedge stone creates an arch-like effect

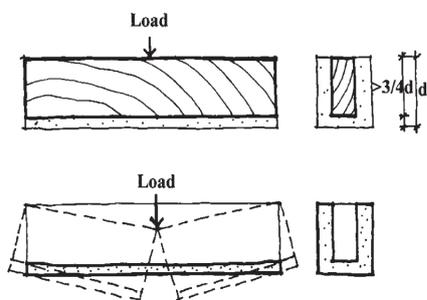
Figure 28: Failure of wooden beam strengthening

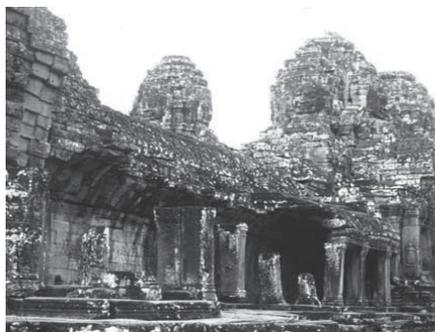
Figure 29: A mixed structural construction technique applied in a gallery of Bayon

While the mass walls were constructed with dry masonry technique, a mixed structural construction technique was sometimes applied in the galleries: one side was a solid wall while the other side consisted of nave and aisle columns. (Figure 29) Moreover, like the opening frame, the stone structure connecting nave and aisle columns with a beam was also derived from wooden structures (JSA 2000). There are two types of column used in Khmer architecture. One is the column constructed from a sandstone monolith, the other is composed of sandstone or laterite blocks in dry bond. The latter might be the result of the masons' concern about the orientation of the bedding plane of sandstone. Since the monolith is placed in edge-bedded orientation, it consequently has a lower capacity of loading support than a series of natural-bedded blocks.⁵ Laterite, by contrast, may have strength problems particularly when used together with sandstone columns or walls.⁶

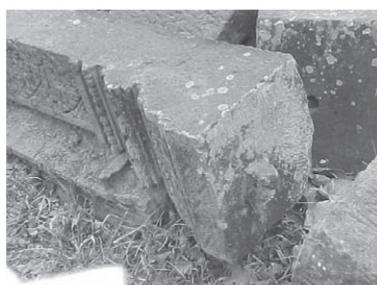
b. Tenon at the bottom of a shaft (Falling column in Banteay Srei, Cambodia)

Figure 30: Mortise-tenon of column

Khmer columns are composed of three parts—a base, shaft, and capital. If the column was a monolith, its capital and shaft were made of one stone piece and its base of another. A mortise and tenon joint technique was applied in order to connect the two parts. The stone tenon, carved from the same monolith, was about 6x6x4 centimetres located on the upper or lower face of each part. However, it is not consistent which element contains a tenon or which one has a mortise. The position of the tenon and mortise is also variable—in some columns, it is in the centre while, in other cases, it is on one side of the face. At the head of the capital, either a tenon or mortise can be found. It might have been used to tie a beam placed over the capital (Figure 30).

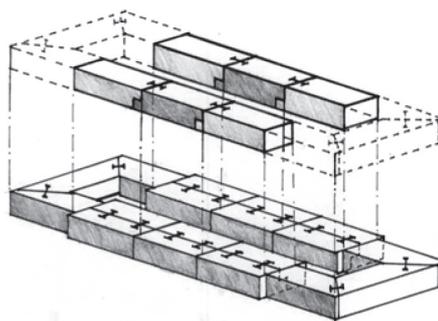
Figure 32: Two-course beam in Khmer architecture

Beams comprise of two courses of stone placed horizontally in a lengthwise direction (from east to west since buildings are planned rectangularly with the shorter sides facing east and west). The beams were possibly placed to support the corbelled roof structure. The lower beam was composed of two stone elements placed next to each other horizontally with the stretcher sides facing each other; beams were tied together with metal clamps and processed so as to form one continuous beam (see Figure 31a and 32). The long sides of the elements were placed next to each other with a halving joint (JSA 2000). Then, another beam was placed on top of them. This upper beam has a halving joint on the header as well. In addition, there are traces of clamps having been used in a lengthwise direction to tie the upper blocks of the beams (Figure 31b). However, the structure of the beams could vary, depending on the loads they had to support.

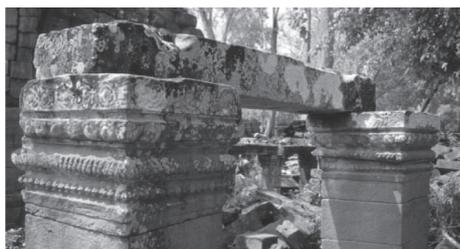
Figure 33: A remaining beam over a pilaster. Generally, a beam is composed of two elements of stone tying together on their stretchers with I- or H-shaped metal clamps. In this structure, one beam is missing (Banteay Chmar, Cambodia)

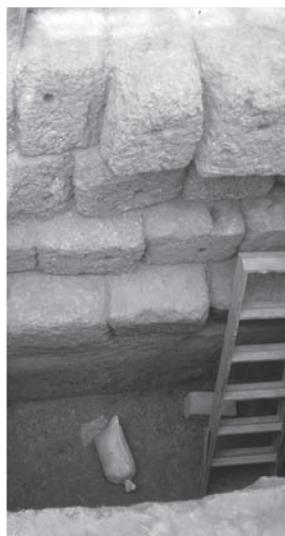
Figure 34: A trench of one of the tower foundation shows layers of different materials starting with sandstone, then, laterite, and finally, soil (Prasat Sao Prat, Cambodia)

The platforms were generally constructed on layers of several materials over the natural soil: sandstone, laterite, stone fragments and soils, for instance (see Figure 34). Ashlar sandstone and/or laterite masonry is often used as pavement material on the surface, while laterite is used inside the platform. The number of masonry courses of the platform varies from site to site. For example, there are three courses of masonry for the platform construction of the Northern Library of Bayon in Angkor (JSA 2000) while there are only two—one in sandstone and the other in laterite—outside of the Northeast Gate of the Royal Palace (IGT 1996). Generally, the total number of stone masonry courses for platform constructions of each level would have been the same within each building. However, the latter site proves an exception in that the numbers of masonry courses are not equal in the interior and exterior of the building. The exterior platform consists of two layers while the interior consists of five (IGT 1996 and see Figure 35). This might have been because of consideration of the greater loads that the interior platform had to bear.

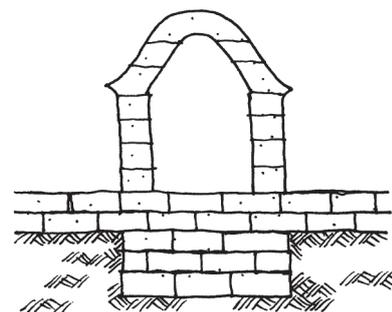
Figure 35: Comparison of courses of platform masonry between interior and exterior

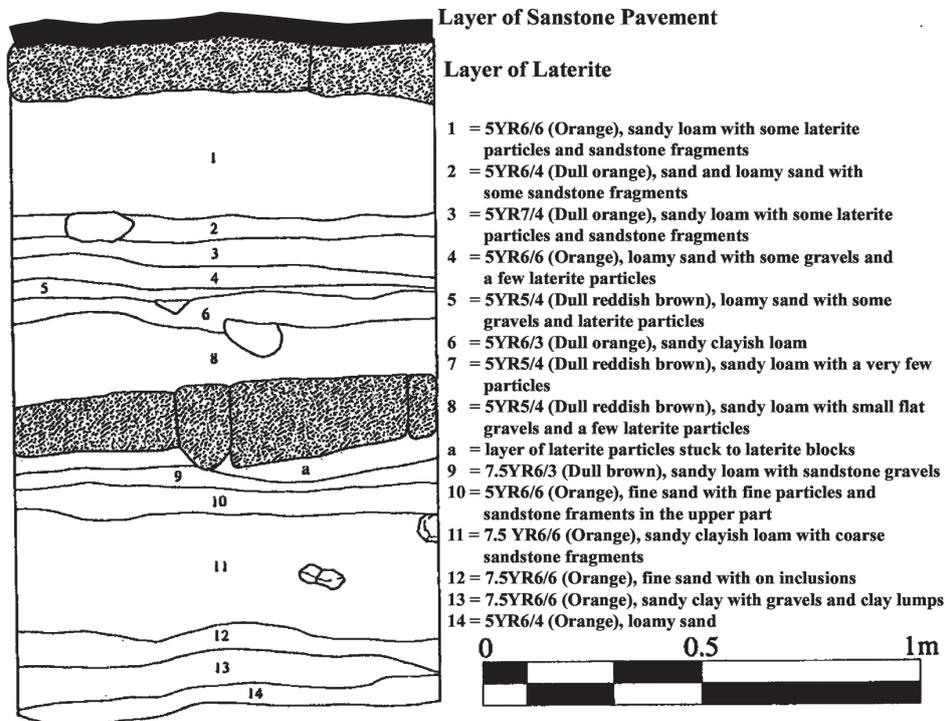
Figure 36: Example of Khmer foundations: Platform of the Northern Library of Bayon, Cambodia (JSA 2000)

were generally paved with sandstone blocks while laterite was used where the floor was protected by the wall construction on top of the platform. Wedge-shaped sandstone blocks were often inserted into the small spaces between the floor elements to fill the gaps and complete the floor work, but there are cases in which soil mixed with sandstone fragments was used instead. Beneath the sandstone layer that formed the floor were laterite blocks as the second (and, sometimes, also the third) course. Beneath this, there is normally a layer of compacted soil; however, in some places there is a tier of laterite blocks. Trench excavation at Bayon shows that within the compacted soil layer sand is also found. The depth of this layer is approximately 50 centimetres. Sometimes, it can be found that this layer is as deep as 160 centimetres from the surface of the platform. At this point another layer of hard material, which seems to be laterite, can be found. However, in some cases, such as the south side of the Northern Library of Bayon, evidence from the excavation confirms that laterite blocks had a depth of 140 centimetres from the terrace surface, below which a layer of compacted soil up to a thickness of 170 centimetres was found. Beneath this, a hard material layer, possibly laterite, was found (JSA 2000). The section drawing of the foundation is shown in Figure 36.

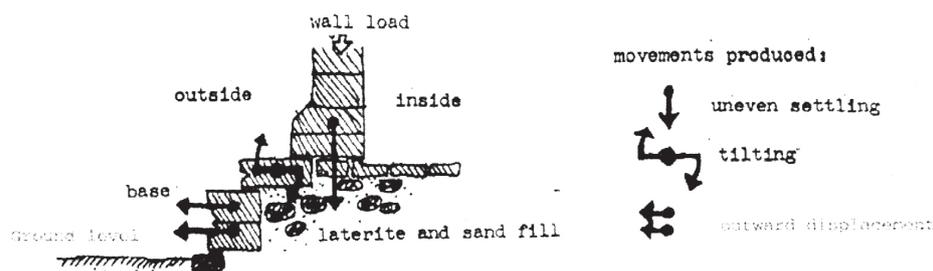
Figure 39: Movement of Khmer Foundation (Pichard 1972)

The main failure of the Khmer structural system was the failure of its foundation (Picard 1972). Being built of such a weak and partly soluble and erodible material as soil, it would inevitably subside. The use of laterite in construction was possibly the other principal cause of the failure. Uneven load-bearing capacity of the foundation resulted in non-uniform movement of the structure leading to overall structural deformation (see Figure 39). For instance, the outward movement of columns and walls consequently caused unbalanced and collapsed corbelled roofs. However, this failure was caused not only by the misuse of material and ineffective design of Khmer architects and masons, but also by the environment, especially the presence of water—either the infiltration of rainwater or groundwater—when the soil becomes saturated the soil begins to behave like a fluid.
