Redefining Wang Na Rattanakosin: The History and Conservation of a Royal Thai Palace

M.L. Bussayamas Nandawan

Faculty of Architecture, King Mongkut's Institute of Technology Ladkrabang

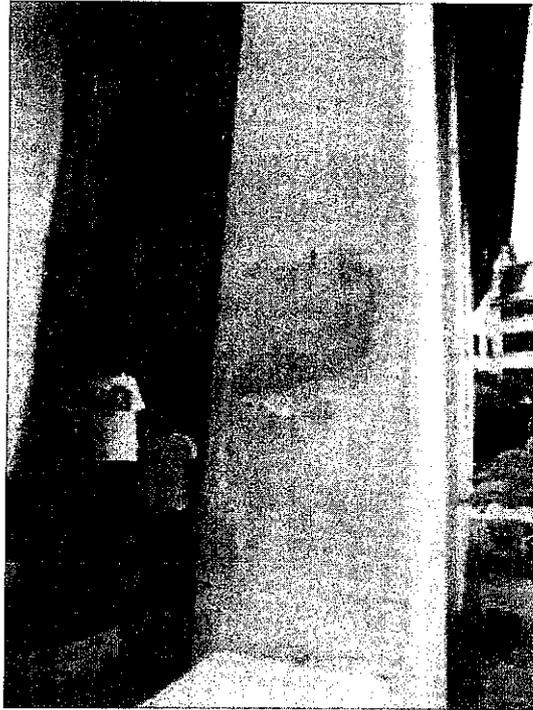
Figure 3: This picture shows the deterioration inside Wat Bavornsataan Suttawas.

In Bangkok the average daily temperature ranges between 22° and 38°C. Humidity is high, throughout most of the year, and the rainfall fairly high during the summer months. It is widely understood fact that the influence of heat in the physical decay of building material is a significant factor because of the expansion and contraction of minerals. The decay due to heat is greatly increased by high humidity. Nearly 90 per cent of the total annual rainfall takes place during the six months of the monsoon while other months are comparatively dry. The continuous changes in the temperature and weather conditions have the effect of straining the outer layer of the building materials which start showing signs of cracks and exfoliation.

1. Humidity
2. Contamination from polluted air
3. Neglect
4. Pests, fungi, bacteria, wood beetles, ants, rats and birds

1. Air pollution can be ruled out in most cases, thus leaving temperature and moisture as the principle causes of the deterioration.
2. Special attention should be given to the growth and damage caused by microorganisms and insects. Proper air circulation and ventilation combined with dehumidifying units are simple safeguards against the accumulation of condensation.

4. As a maintenance plan, fungicides and insecticides should be applied to wooden building material regularly.
5. All metal parts should be coated with a protective insecticidal and fungicidal varnish.

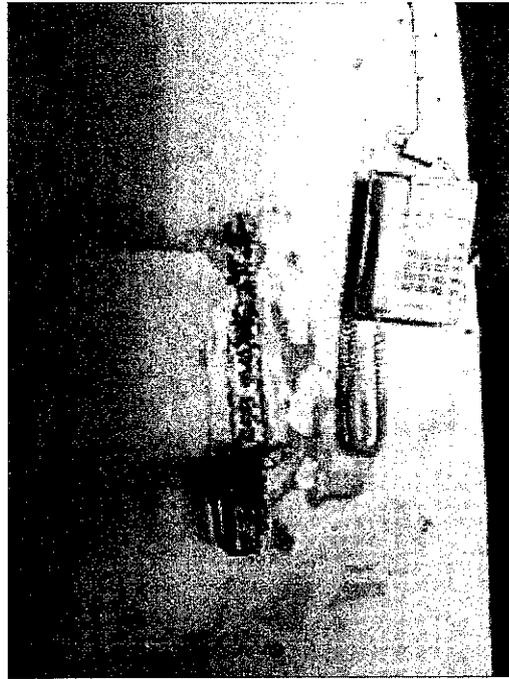
Figure 4: The crack of the pole at the Phuthaisawan Chapel.
Photo taken in 2007
